Removal Action Report

PCE Chestnut Street Site, Atlantic, Iowa

U.S. EPA Region 7 START 4, Contract No. EP-S7-13-06, Task Order No. 0126

REMOVAL ACTION REPORT PCE CHESTNUT STREET – ATLANTIC, IOWA

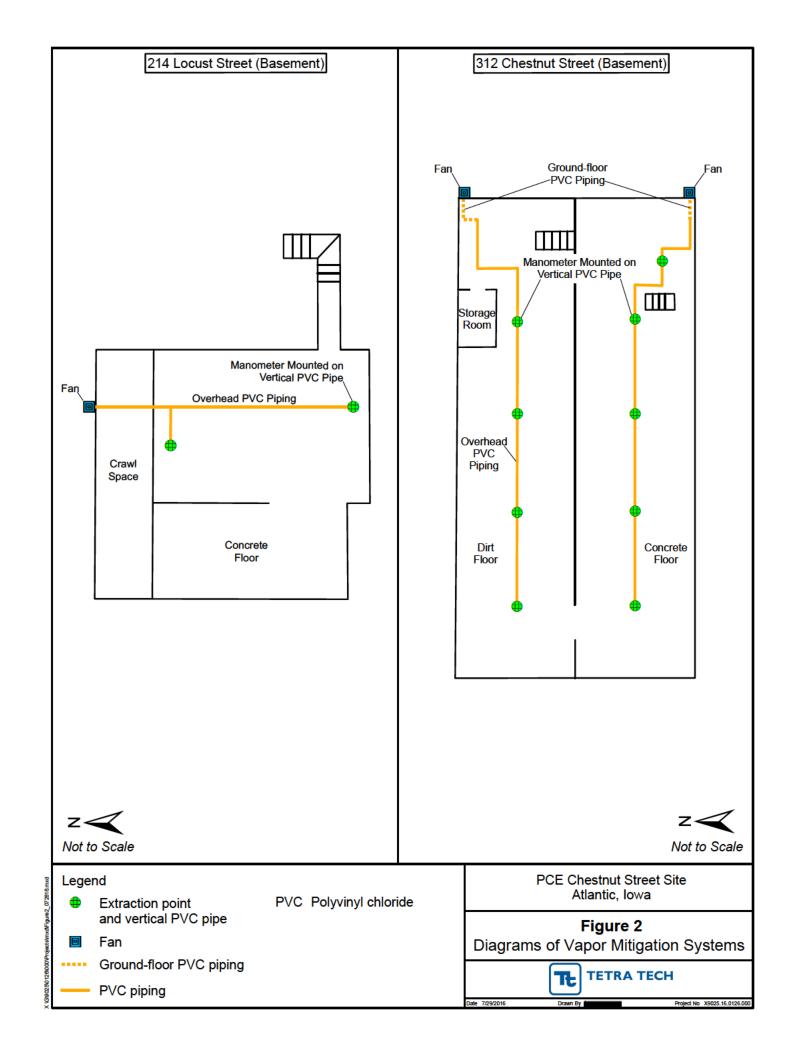
For the south system, five 4-inch-diameter holes were drilled through the concrete floor for vertical PVC extraction pipes. Approximately 1 cubic foot of soil was removed from each hole. The five vertical extraction pipes were attached to overhead horizontal PVC piping and inserted into the holes that had been drilled in the floor. Flexible backer rod and polyurethane caulk were used to seal the bottom of each vertical pipe into the cored hole. Diagrams of both systems are shown on Figure 2 in Appendix A.

On June 14, 2016, Platinum installed a vapor mitigation system at the residence at 214 Locust Street. Two extraction points were drilled into the concrete floor of the unfinished basement for this system, which was installed in the same manner as described for the systems at 312 Chestnut Street. Exhaust piping was routed through a crawl space under the north portion of the house, and a fan for the system (same make and model as those installed at the commercial building at 312 Chestnut Street) was mounted on the north side of the house. A diagram of the system installed at 214 Locust Street is shown on Figure 2 in Appendix A.

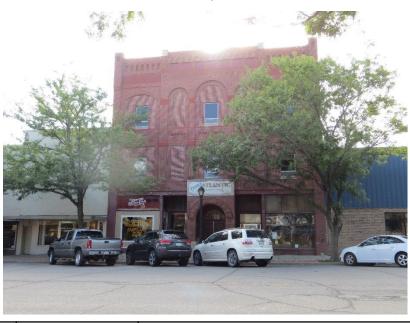
TETRA TECH PROJECT NO.	PHOTO DESCRIPTION	This photograph shows storefronts of the commercial building at 312 Chestnut Street where two mitigation systems were installed in the basement.	1
X9025.16.0126.000	CLIENT	U.S. Environmental Protection Agency Region 7	Date
Direction: East	PHOTOGRAPHER		6/14/16

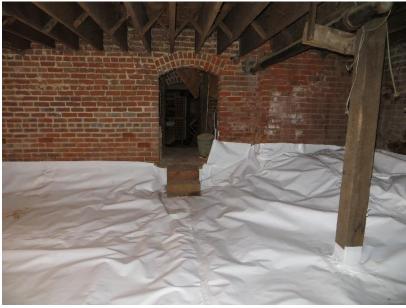
TETRA TECH PROJECT NO.	PHOTO DESCRIPTION	This photograph shows a walkway between the north and south portions of the basement at 312 Chestnut Street.	2
X9025.16.0126.000	CLIENT	U.S. Environmental Protection Agency Region 7	Date
Direction: South	PHOTOGRAPHER		6/13/16

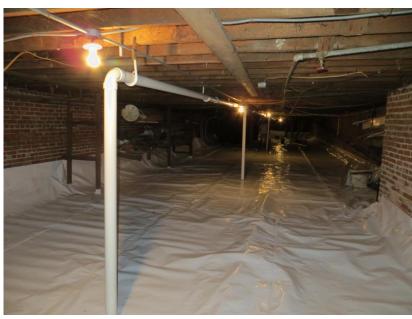
TETRA TECH PROJECT NO.	PHOTO DESCRIPTION	This photograph shows the vapor barrier membrane and polyvinyl chloride (PVC) piping for the mitigation system in the north side of the basement at 312 Chestnut Street.	3
X9025.16.0126.000	CLIENT	U.S. Environmental Protection Agency Region 7	Date
Direction: East	PHOTOGRAPHER		6/13/16

For the north system, Platinum placed a 12-mil, polyester-enforced, polyethylene vapor barrier membrane over Mar-flex high-density, dimpled, polyethylene matting that had been placed on the ground surface. The membrane was extended up the basement walls about 3 feet above ground surface in all areas, and was secured to the walls with nails and caulk. The membrane was also taped to the base of ceiling supports in the basement. Four vertical PVC extraction pipes were connected to a horizontal PVC pipe hung below the floor joists for the ground floor of the building. The bottoms of the vertical pipes were inserted into holes cut into the membrane and then sealed with tape. The horizontal PVC piping was extended to the northeast corner of the building, where it was directed up through the ground floor and into the upper portion of a closet along the east wall. The piping was then turned to the north—into the overhead area of a former small bathroom—and then back to the east through the exterior building wall.

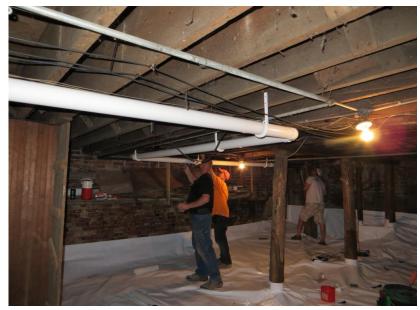
TETRA TECH PROJECT NO.	PHOTO DESCRIPTION	This photograph shows installation of overhead PVC piping for the north mitigation system at 312 Chestnut Street.	4
X9025.16.0126.000	CLIENT	U.S. Environmental Protection Agency Region 7	Date
Direction: Northeast	PHOTOGRAPHER		6/13/16

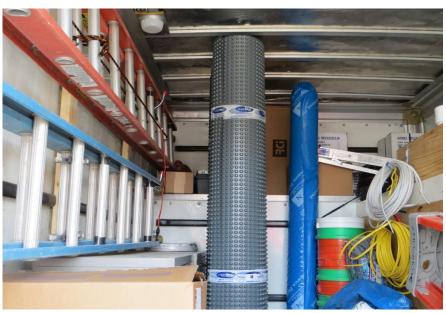
TETRA TECH PROJECT NO.	PHOTO DESCRIPTION	This photograph shows textured material that was placed under the vapor barrier membrane in the north half of the basement at 312 Chestnut Street (dirt floor).	5
X9025.16.0126.000	CLIENT	U.S. Environmental Protection Agency Region 7	Date
Direction: NA	PHOTOGRAPHER		6/13/16

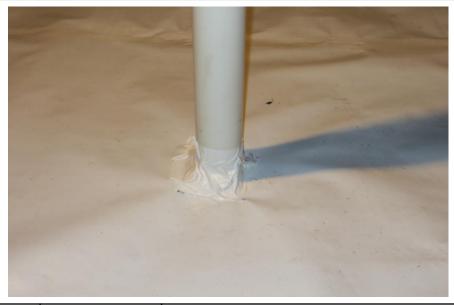
TETRA TECH PROJECT NO.	PHOTO DESCRIPTION	This photograph shows a vertical PVC extraction pipe taped to the membrane covering the dirt floor at the north side of the basement at 312 Chestnut Street.	6
X9025.16.0126.000	CLIENT	U.S. Environmental Protection Agency Region 7	Date
Direction: NA	PHOTOGRAPHER		6/13/16

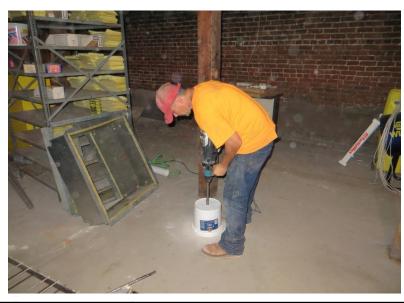
TETRA TECH PROJECT NO. X9025.16.0126.000	PHOTO DESCRIPTION	This photograph shows coring of a hole through the concrete floor at the south side of the basement at 312 Chestnut Street, where a vertical extraction pipe would be installed; a bucket is being used as a dust shroud.	7
11,023.10.0120.000	CLIENT	U.S. Environmental Protection Agency Region 7	Date
Direction: Northwest	PHOTOGRAPHER		6/13/16

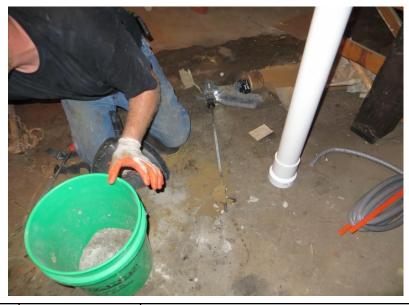
TETRA TECH PROJECT NO.	PHOTO DESCRIPTION	This photograph shows a hand drill with an auger bit that was used to loosen dirt/gravel beneath holes cored through the concrete floor.	8
X9025.16.0126.000	CLIENT	U.S. Environmental Protection Agency Region 7	Date
Direction: NA	PHOTOGRAPHER		6/13/16

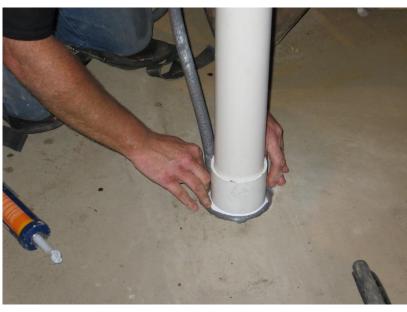
TETRA TECH PROJECT NO.	PHOTO DESCRIPTION	This photograph shows placement of backer rod to help seal the space between a vertical PVC extraction pipe and the cored hole.	9
X9025.16.0126.000	CLIENT	U.S. Environmental Protection Agency Region 7	Date
Direction: NA	PHOTOGRAPHER		6/13/16

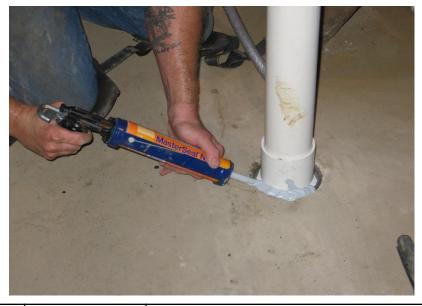
TETRA TECH PROJECT NO.	PHOTO DESCRIPTION	This photograph shows application of caulk on top of a backer rod that had been placed around a PVC extraction pipe.	10
X9025.16.0126.000	CLIENT	U.S. Environmental Protection Agency Region 7	Date
Direction: NA	PHOTOGRAPHER		6/13/16

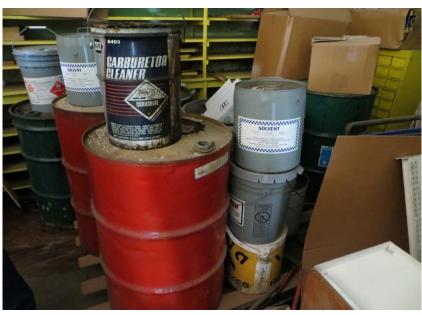
During installation of the vapor mitigation systems, miscellaneous containers of solvents/cleaners, hydraulic oil, etc., were observed on the ground floor of the south portion of the building (see Appendix B); several of the containers were empty. The containers included 12 55-gallon drums, 1 15-gallon drum, and 20-25 5-gallon buckets. Label information on the containers did not indicate that the materials contained PCE or TCE. Also, approximately 70 used/junk lead-acid batteries were observed.

TETRA TECH PROJECT NO.	PHOTO DESCRIPTION	This photograph shows chemical containers in the southeast portion of the building at 312 Chestnut Street (ground floor).	11
X9025.16.0126.000	CLIENT	U.S. Environmental Protection Agency Region 7	Date
Direction: NA	PHOTOGRAPHER		6/14/16

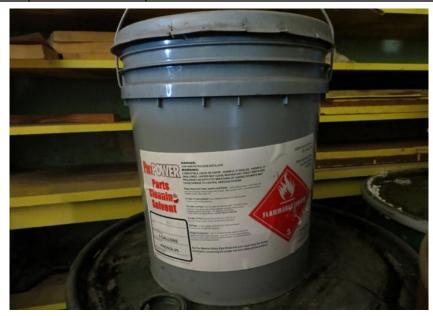
TETRA TECH PROJECT NO.	PHOTO DESCRIPTION	This photograph shows a 5-gallon solvent container in the southeast portion of the building at 312 Chestnut Street (ground floor).	12
X9025.16.0126.000	CLIENT	U.S. Environmental Protection Agency Region 7	Date
Direction: NA	PHOTOGRAPHER		6/14/16

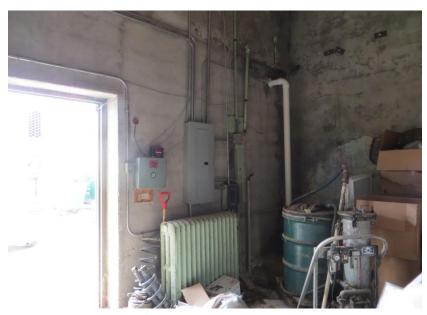
TETRA TECH PROJECT NO.	PHOTO DESCRIPTION	This photograph shows PVC exhaust piping for the south system at 312 Chestnut Street, exiting the east side of the building on the ground floor.	13
X9025.16.0126.000	CLIENT	U.S. Environmental Protection Agency Region 7	Date
Direction: Southeast	PHOTOGRAPHER		6/14/16

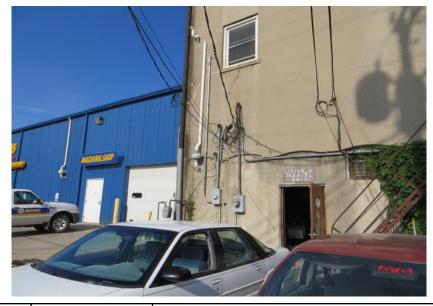
TETRA TECH PROJECT NO.	PHOTO DESCRIPTION	This photograph shows the fan and PVC exhaust piping for the south system mounted outside the east wall of the 312 Chestnut Street building.	14
X9025.16.0126.000	CLIENT	U.S. Environmental Protection Agency Region 7	Date
Direction: Southwest	PHOTOGRAPHER		6/14/16

For each system, a fan (AMG Eagle, manufactured by Festa Manufacturing Enterprises LLC; 160 watts, 1.37 maximum amps, fan speed: 3,150 revolutions per minute) was mounted to the east side of the building, along with PVC exhaust piping that extended above the fan. On June 14, 2016, Platinum completed installation of electrical conduit and wiring for both systems. Upon completion, START

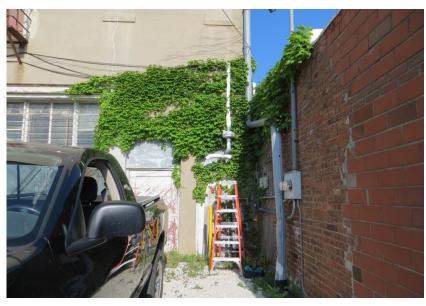
TETRA TECH PROJECT NO.	PHOTO DESCRIPTION	This photograph shows the fan and PVC exhaust piping for the north system mounted outside the east wall of the 312 Chestnut Street building.	15
X9025.16.0126.000	CLIENT	U.S. Environmental Protection Agency Region 7	Date
Direction: West	PHOTOGRAPHER		6/14/16

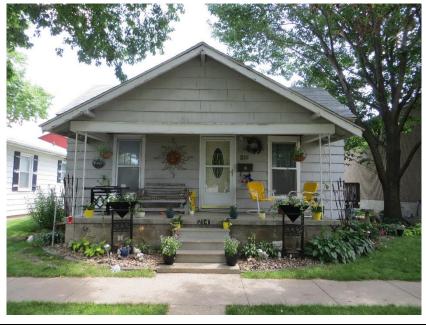
TETRA TECH PROJECT NO.	PHOTO DESCRIPTION	This photograph shows the residence at 214 Locust Street where a vapor mitigation system was installed.	16
X9025.16.0126.000	CLIENT	U.S. Environmental Protection Agency Region 7	Date
Direction: East	PHOTOGRAPHER		6/14/16

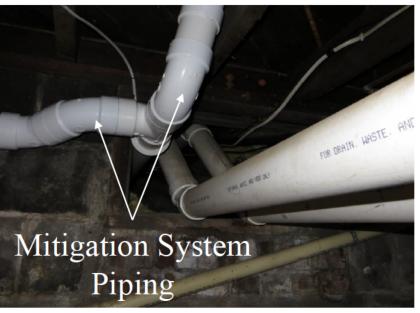
TETRA TECH PROJECT NO.	PHOTO DESCRIPTION	This photograph shows overhead PVC piping (with T-fitting) in the basement of a residence at 214 Locust Street.	17
X9025.16.0126.000	CLIENT	U.S. Environmental Protection Agency Region 7	Date
Direction: North	PHOTOGRAPHER		6/14/16

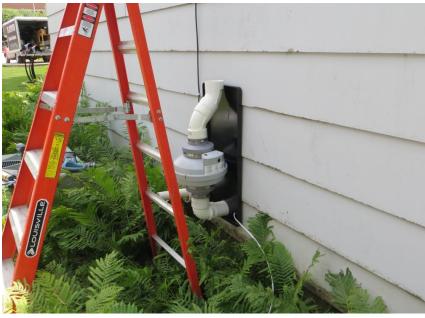
TETRA TECH PROJECT NO.	PHOTO DESCRIPTION	This photograph shows the mitigation system fan installed on the north side of the residence at 214 Locust Street.	19
X9025.16.0126.000	CLIENT	U.S. Environmental Protection Agency Region 7	Date
Direction: Southeast	PHOTOGRAPHER		6/14/16

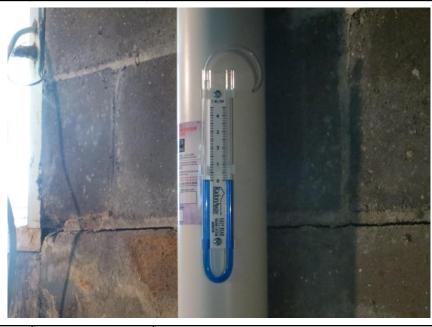
TETRA TECH PROJECT NO.	PHOTO DESCRIPTION	This photograph shows a monometer mounted on a vertical PVC extraction pipe (before fan was operating).	20
X9025.16.0126.000	CLIENT	U.S. Environmental Protection Agency Region 7	Date
Direction: Southeast	PHOTOGRAPHER		6/14/16
